# Heritage at Risk

There are 393 assets on the East of England Register, 19 fewer than in 2016

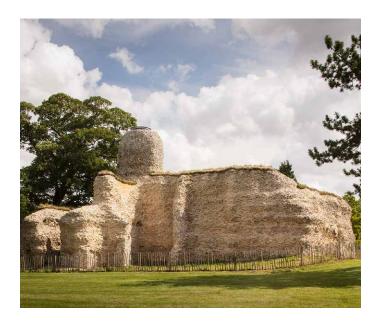
Walden Castle went onto the Heritage at Risk Register because uncontrolled vegetation growth and exposure to the elements were causing decay and collapse of the rubble walls. With advice and grant support from Historic England, in 2013 Uttlesford District Council embarked on a programme of stabilisation and repairs, now complete, which included protecting the walls with a 'soft capping' of carefully selected grass and other plants. As a result,

Walden Castle came off the Register in 2017. Landscaping work and improved interpretation will complete the scheme, making the castle once again fully accessible to the public.
